# Historical Preservation Commission Agenda

**Monday September 18, 2023 at 4:00 P.M.**

Property owner Boys and Girls Club of Weld County, Inc Executive Director Terry Adams requests approval for exterior alterations of the Warnoco Building. The alterations include masonry repointing, window replacement, new entrances on the east and west sides and completion of the east vestibule.

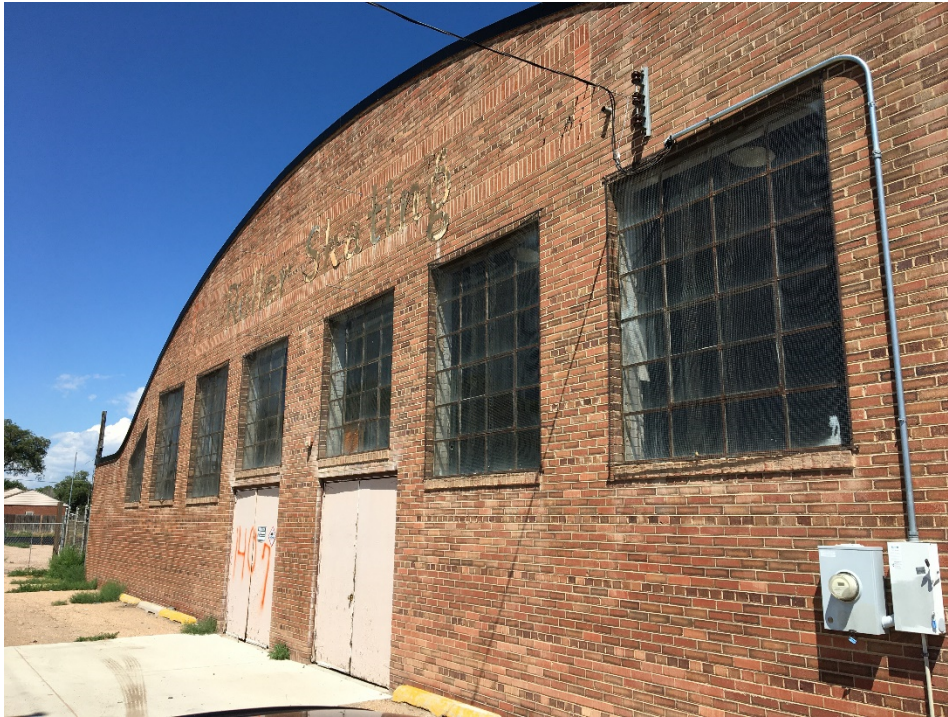
South façade, looking northwest

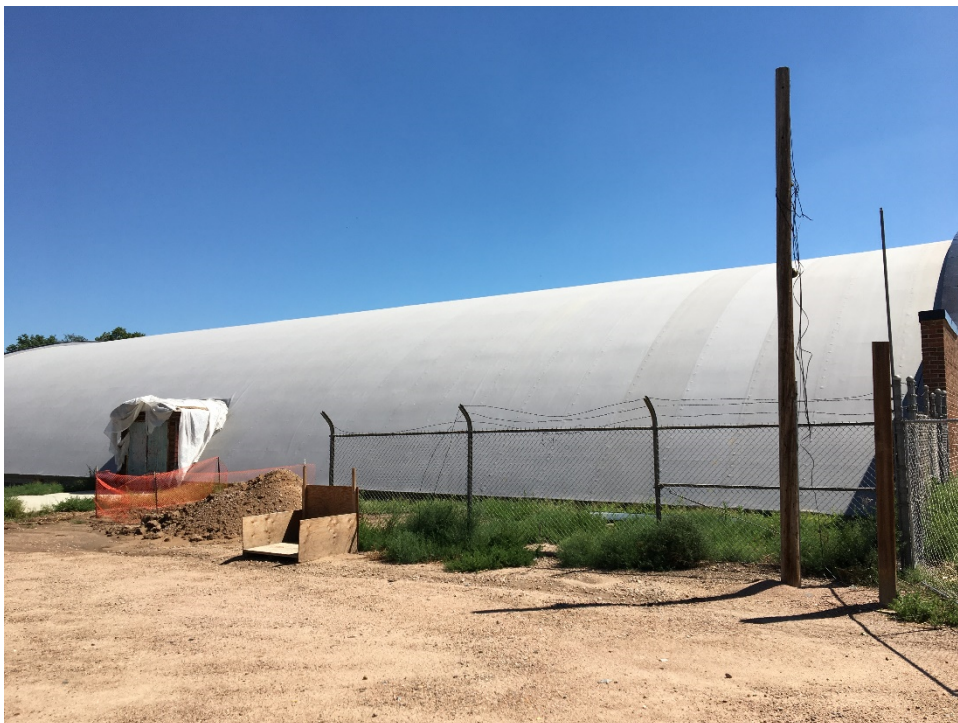
West façade, looking east-northeast

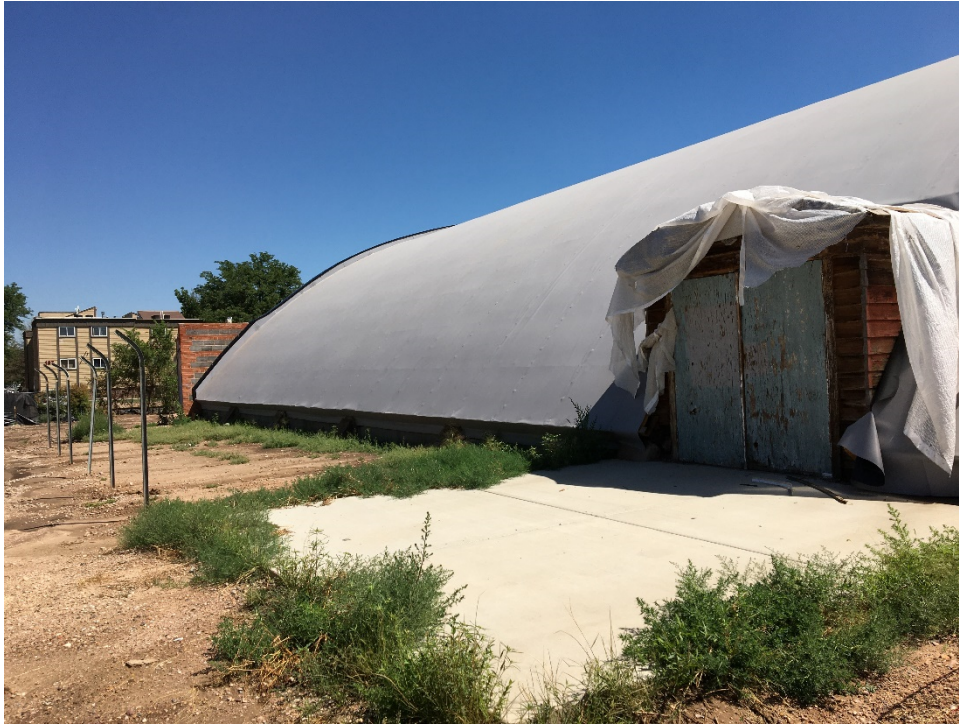
West façade looking north-northeast

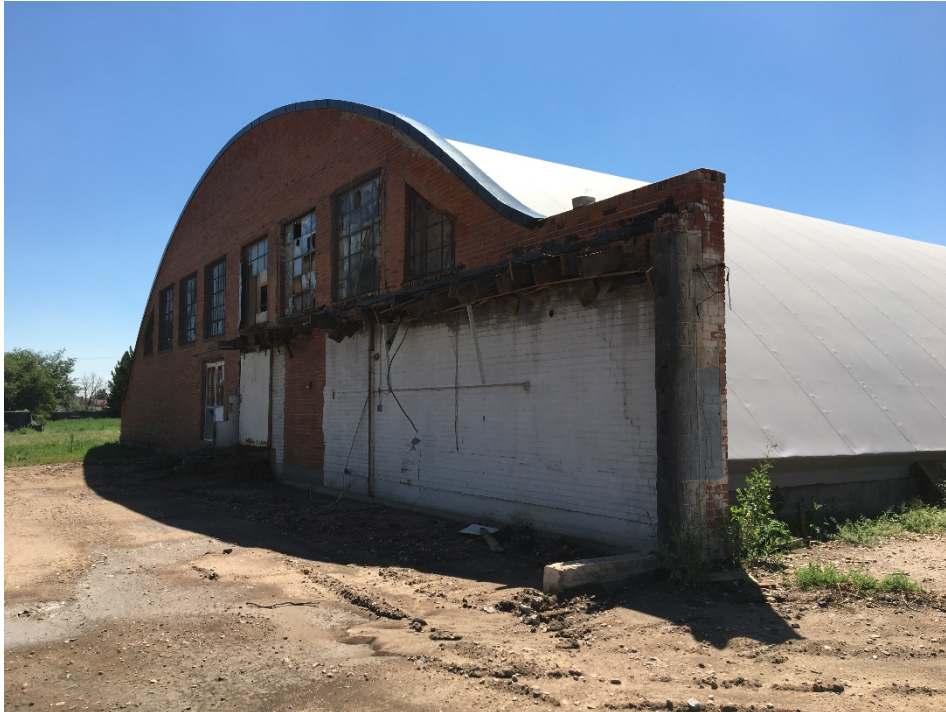
North façade, looking southeast

A number of lights of the metal frame windows are broken or missing, particularly on the north elevation. The remnants of the north concrete addition that was used for storage most recently are evident on the west end of the north elevation. The addition was demolished in July 2023.

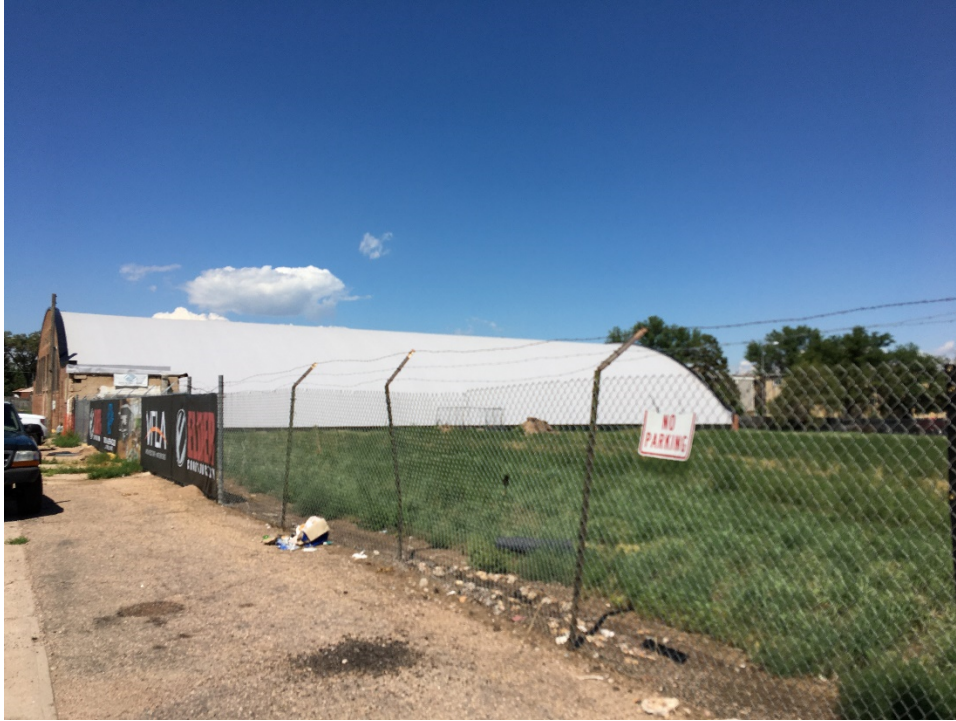
East façade, looking west

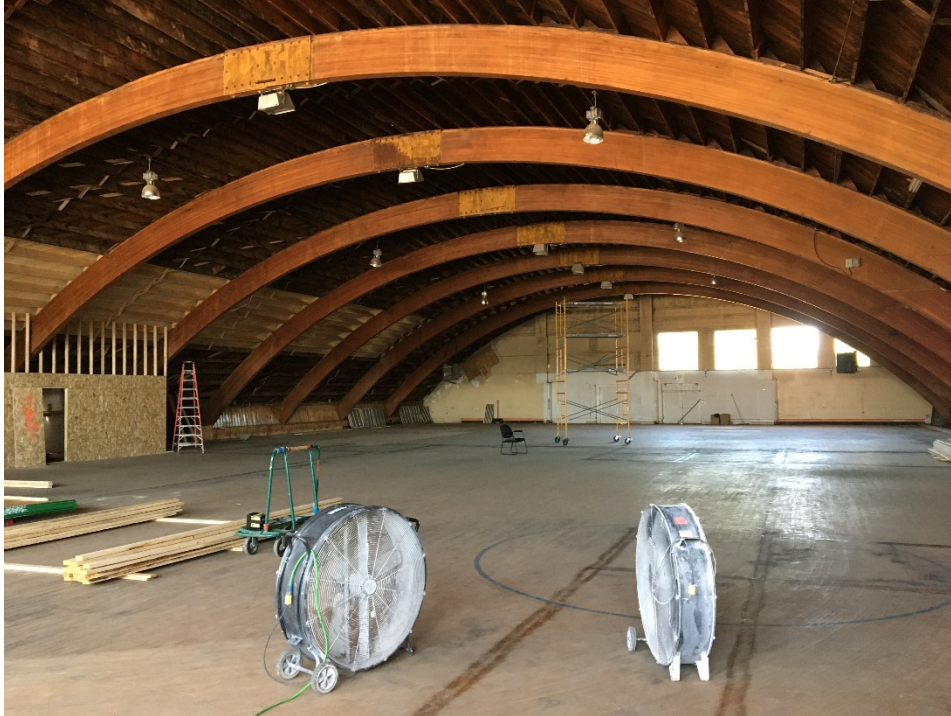
Interior, looking north

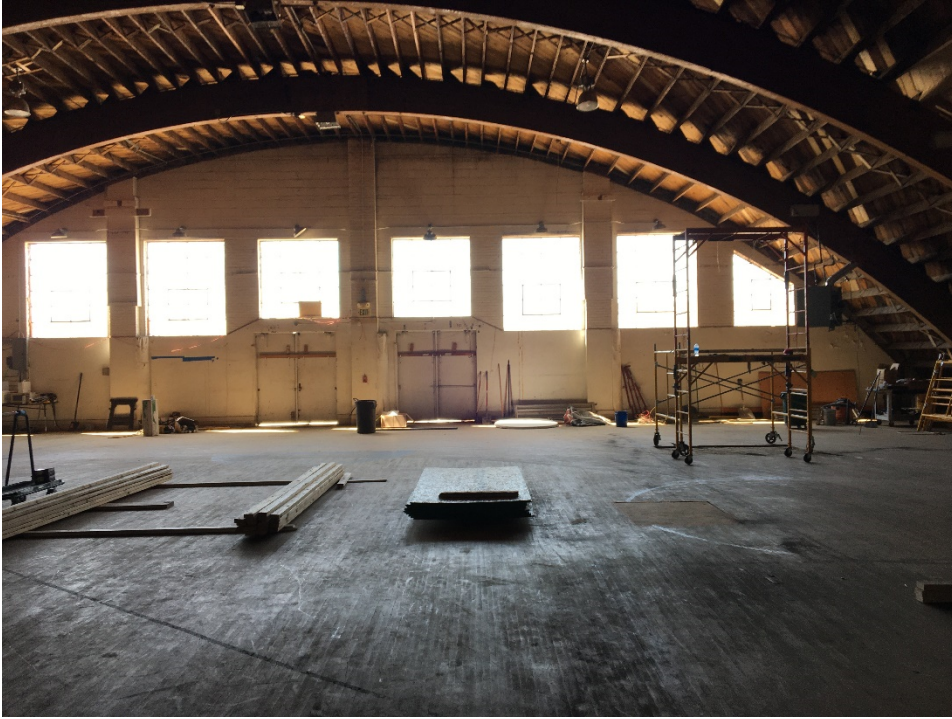
Interior, looking south

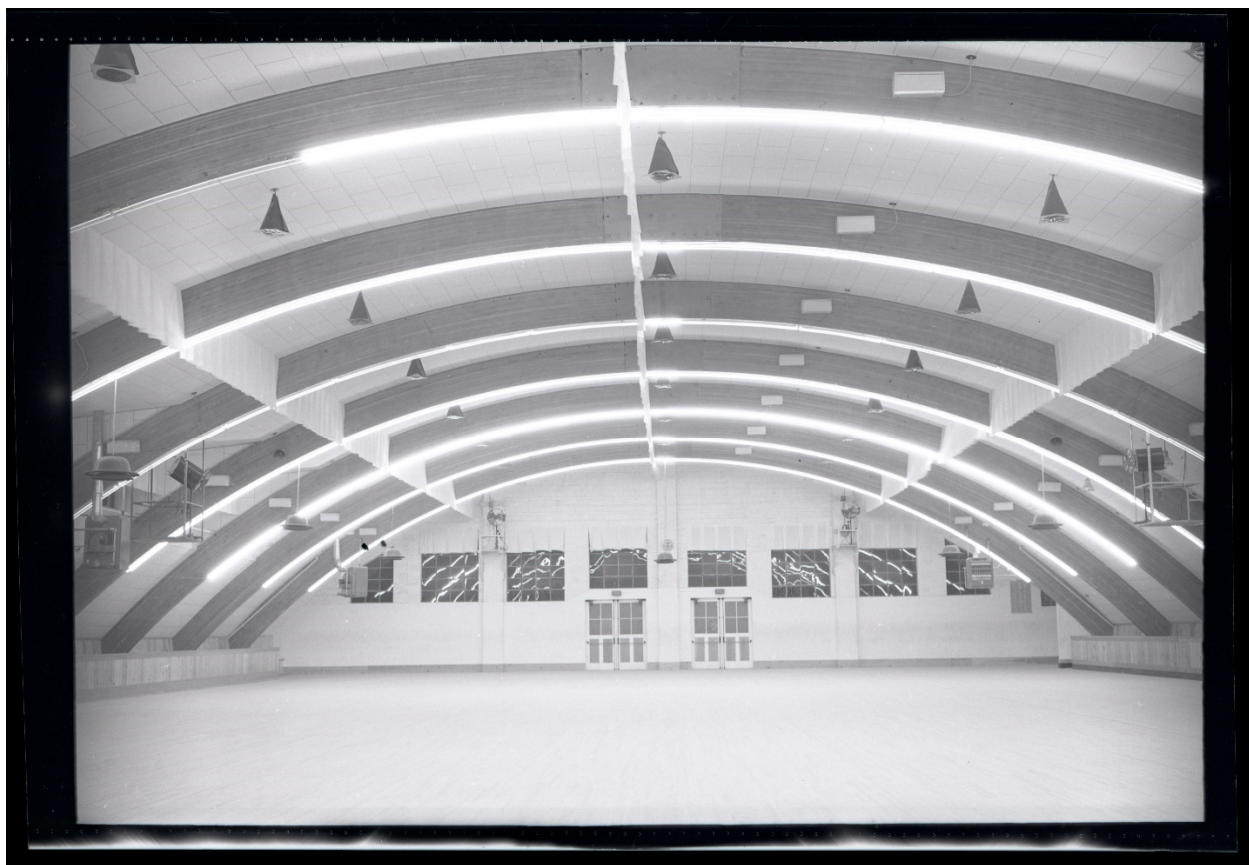
2000.04.0003.13, City of Greeley Museums, Skeets Calvin Collection. Warnoco building interior, date unknown, photograph by Millard Darwin "Skeets" Calvin.

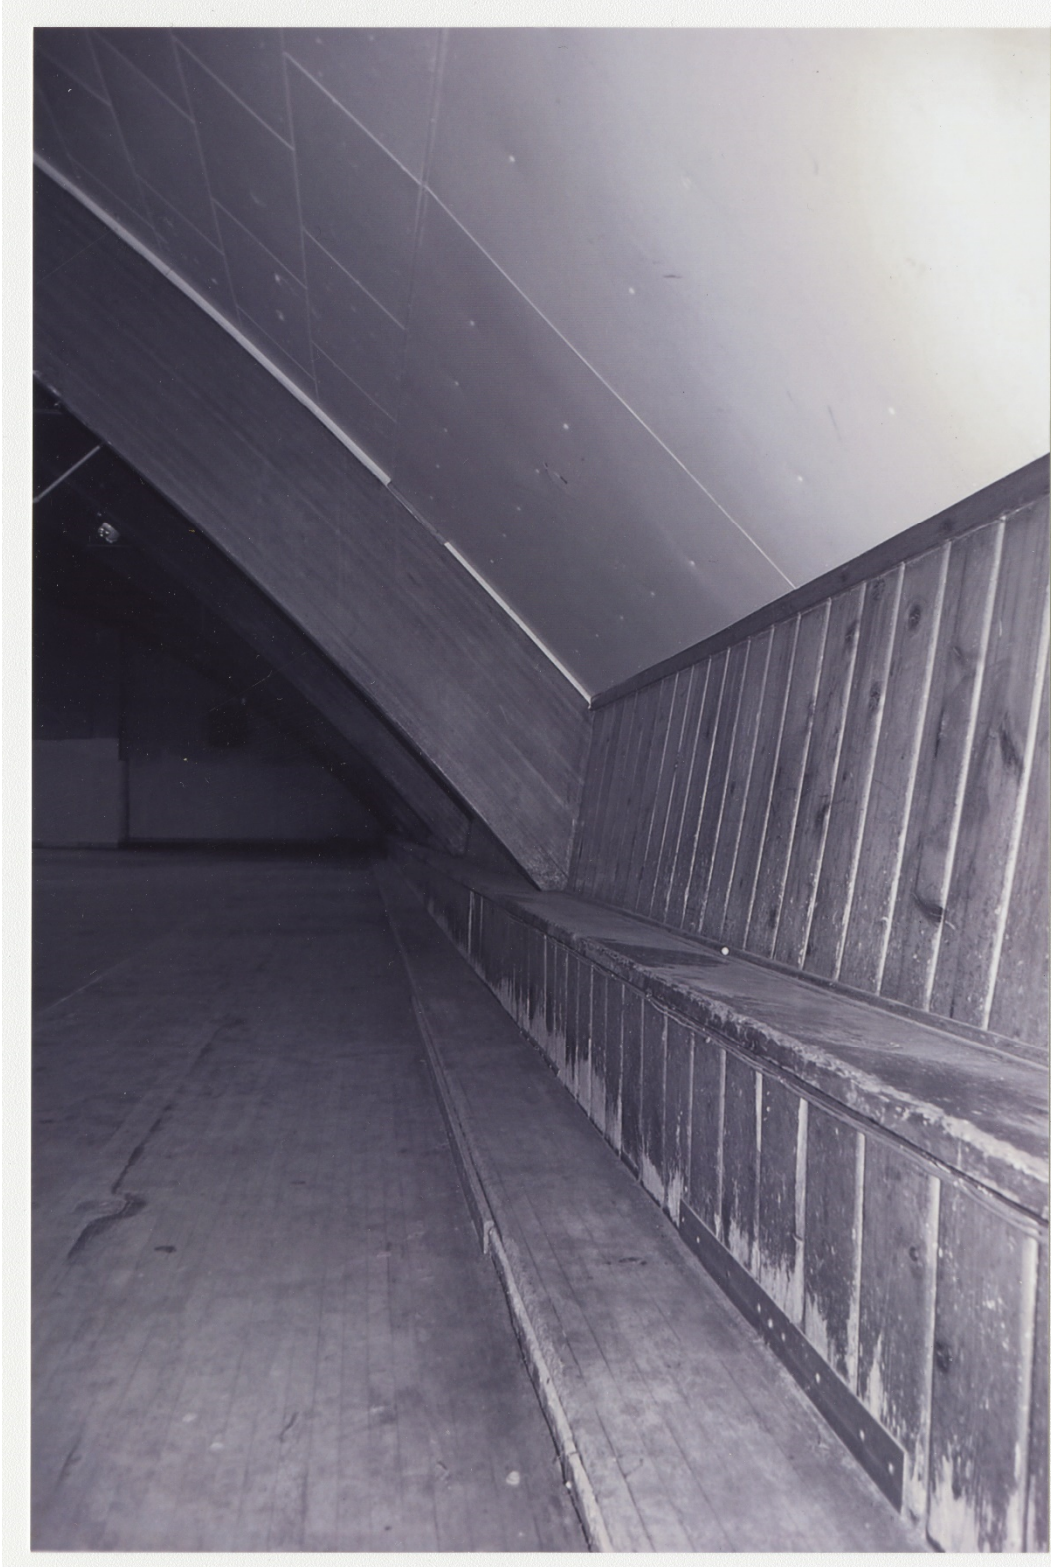
2010.120.0002.1, City of Greeley Museums, Permanent Collection. Warnoco building interior, date unknown, photographer unknown.

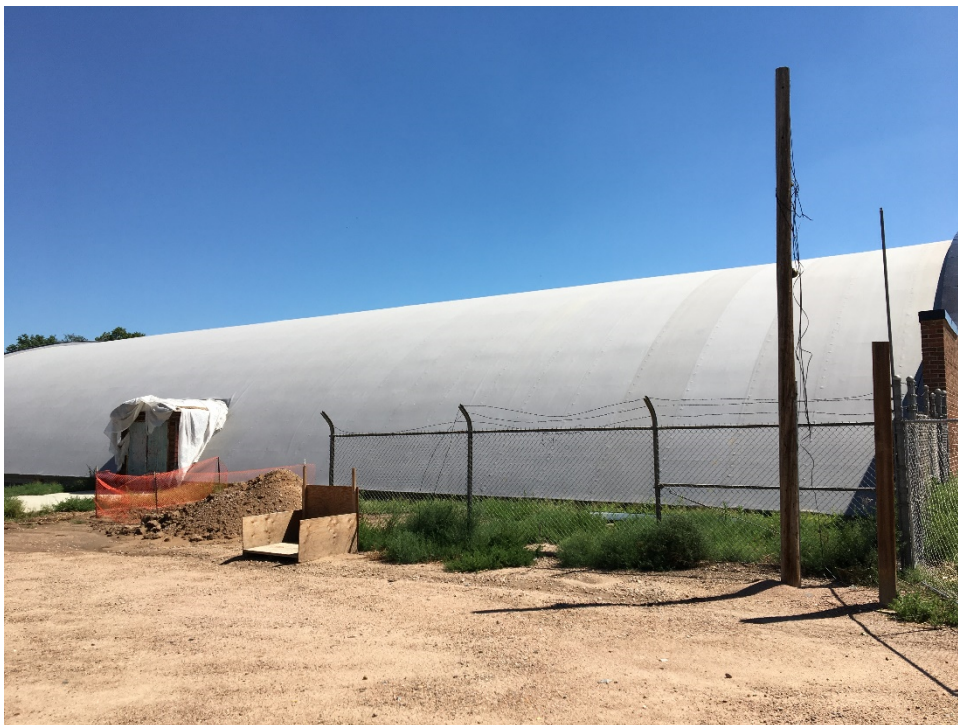
West façade, looking east-northeast

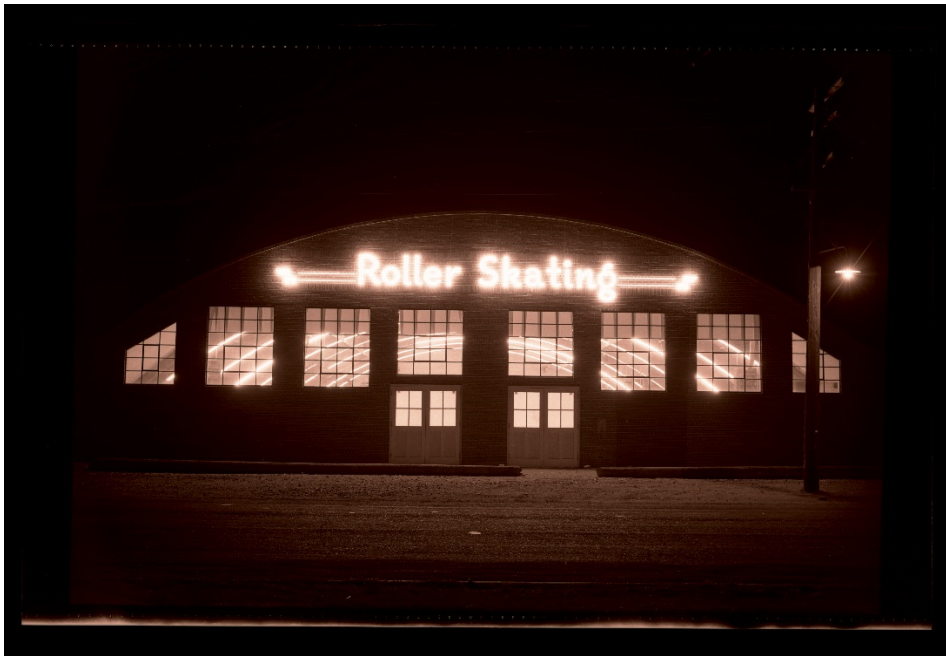
2000.04.0003.2, City of Greeley Museums, Skeets Calvin Collection. Warnoco building, date unknown, photograph by Millard Darwin "Skeets" Calvin.

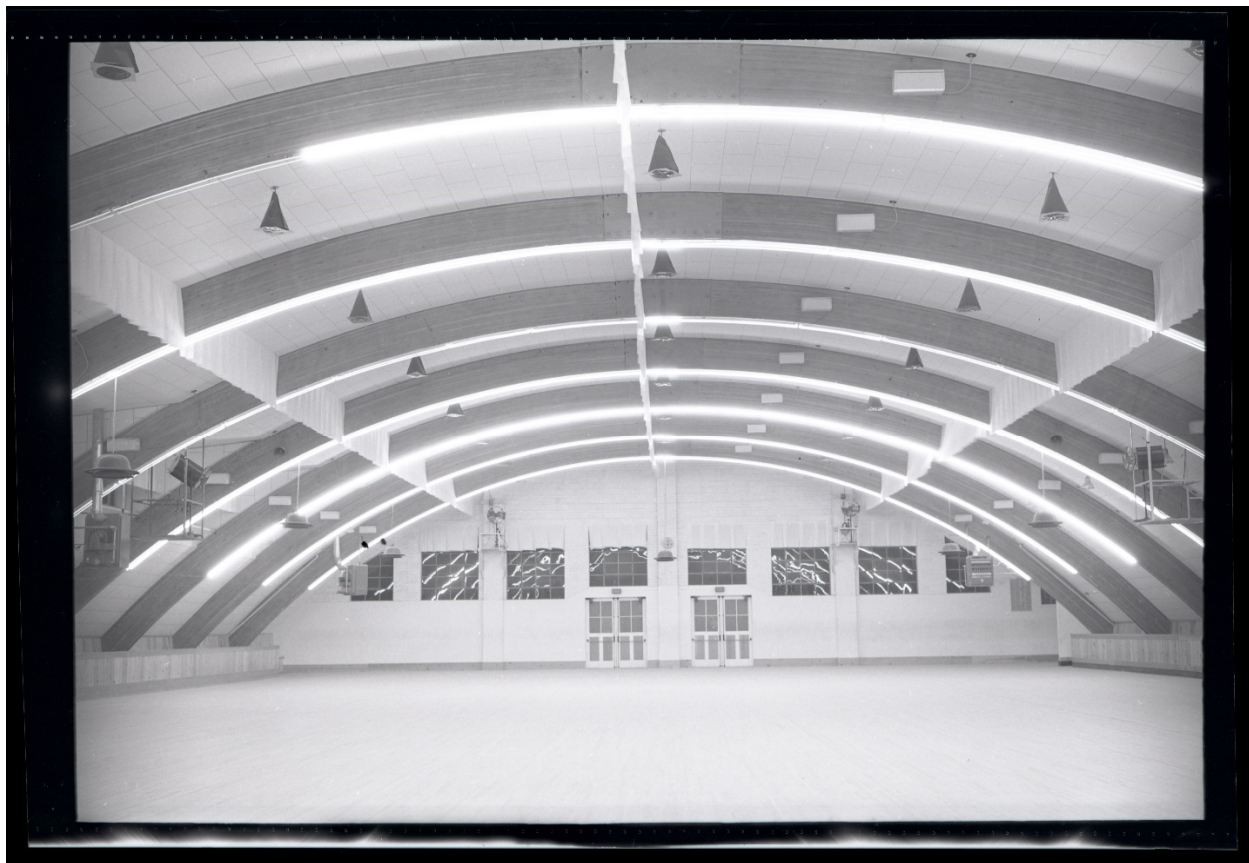
2000.04.0003.13, City of Greeley Museums, Skeets Calvin Collection. Warnoco building interior, date unknown, photograph by Millard Darwin "Skeets" Calvin.

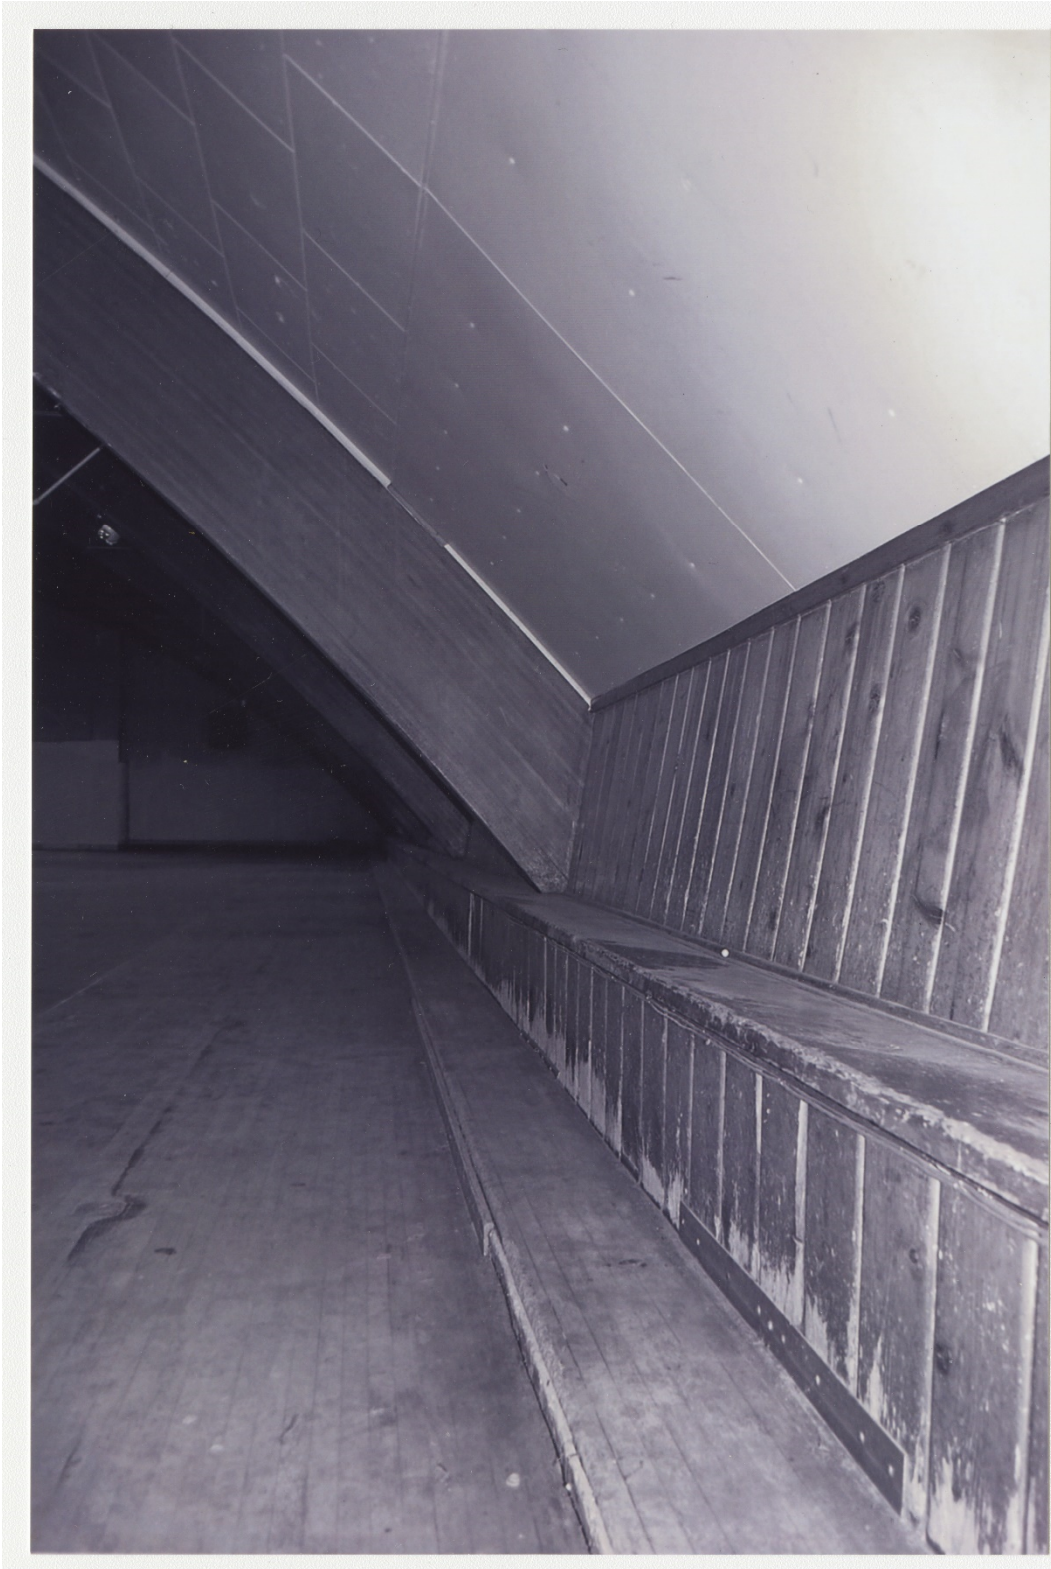
2010.120.0002.1, City of Greeley Museums, Permanent Collection. Warnoco building interior, date unknown, photographer unknown.

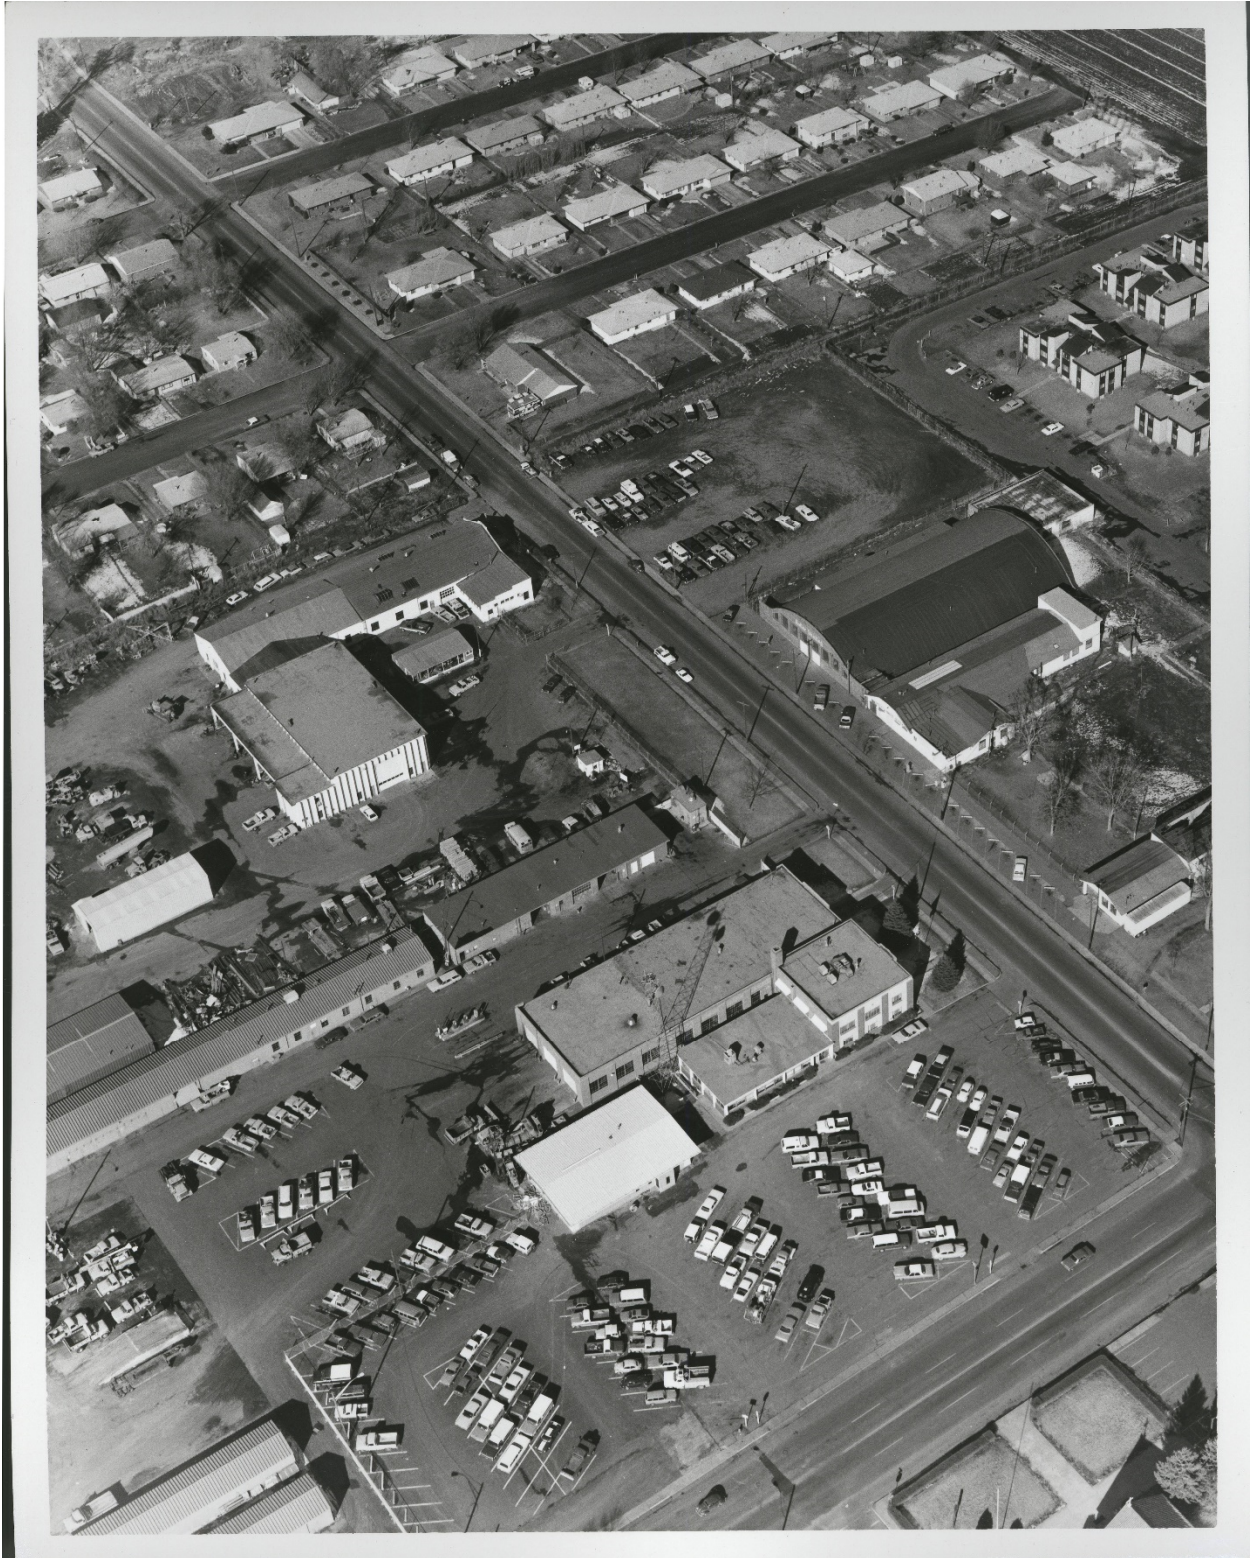
1992.75.0343, City of Greeley Museums, Lew Dakan Collection. Warnoco Park aerial, February 22, 1978, photograph by Lew Dakan.

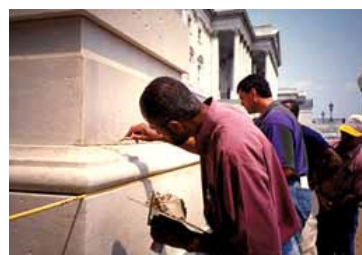
Masons practice using lime putty mortar to repair historic marble. Photo: NPS files.

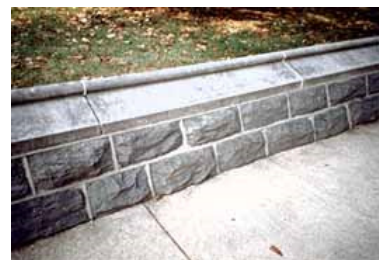
Caulking was inappropriately used here in place of mortar on the top of the wall. As a result, it has not been durable. Photo: NPS files.

For repointing, lime should conform to ASTM C 207, Type S, or Type SA, Hydrated Lime for Masonry Purposes. This machine-slaked lime is designed to assure high plasticity and water retention. The use of quicklime which must be slaked and soaked by hand may have advantages over hydrated lime in some restoration projects if time and money allow.

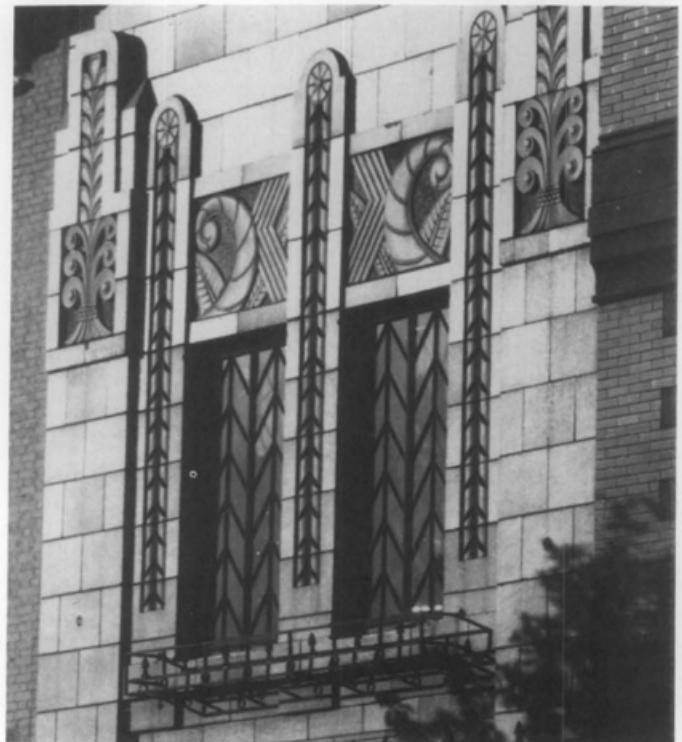
*Fig. 1 Often highly distinctive in design and craftsmanship, rolled steel windows play an important role in defining the architectural character of many later nineteenth and early twentieth century buildings. Art Deco, Art Moderne, the International Style, and Post World War II Modernism depended on the slim profiles and streamlined appearance of metal windows for much of their impact. Photo: William G. Johnson.*

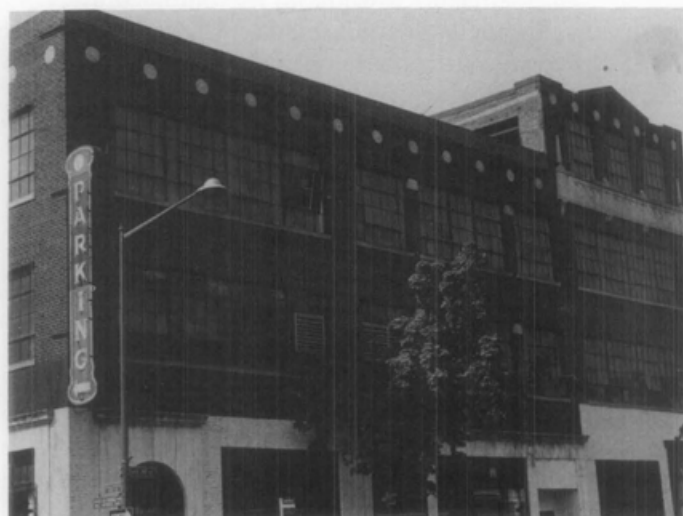
Fig. 5 Windows often provide a strong visual element to relatively simple or unadorned industrial or commercial buildings. This design element should be taken into consideration when evaluating the significance of the windows. Photo: Michael

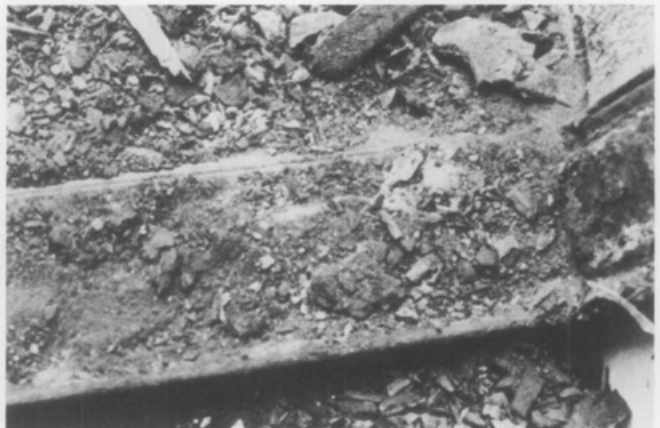
Fig. 6 d. View looking down towards the sill. The subframes appeared very rusted, but were in good condition once debris was vacuumed and surface rust was removed, in place, with chemical compounds. Where necessary, epoxy and steel filler was used to patch depressions in order to make the subframe serviceable again.

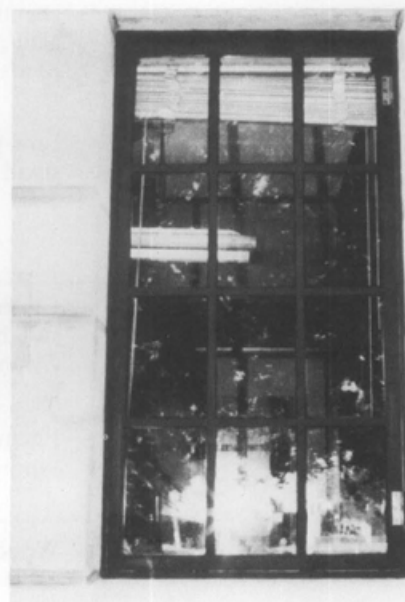
Fig. 6 f. View from the outside of the completely refurbished window. In addition to the steel repair and the installation of vinyl weatherstripping, the exterior was caulked with polyurethane and the single glass was replaced with individual lights of thermal glass. The repaired and upgraded windows have comparable energy efficiency ratings to new replacement units while retaining the historic steel sash, frames and subframes.

The third method of installing an added layer of glazing is to replace the original single glazing with thermal glass. Except in rare instances in which the original glass is of special interest (as with stained or figured glass), the glass can be replaced if the hinges can tolerate the weight of the additional glass. The rolled metal sections for steel windows are generally from 1" - 1 1/2" thick. Sash of this thickness can normally tolerate thermal glass, which ranges from 3/8" - 5/8". (Metal glazing beads, readily available, are used to reinforce the muntins, which hold the glass.) This treatment leaves the window fully operational while preserving the historic appearance. It is, however, the most expensive of the treatments discussed here. (See fig. 6f).

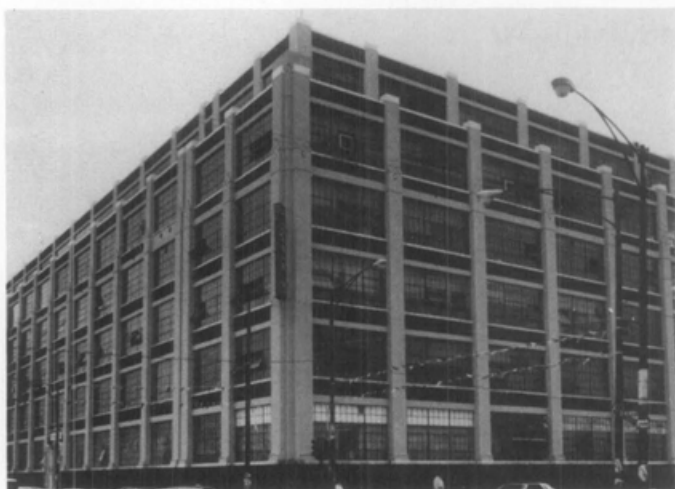
Fig. 10 a. A six-story concrete manufacturing building prior to the replacement of the steel pivot windows. Photo: Charles Parrott.

historic windows, most of these manufacturers can reproduce the historic configuration if requested, and the cost is not excessive for large orders (see figs. 10a and 10b). Some manufacturers still carry the standard pre-World War II multi-light windows using the traditional 12" x 18" or 14" x 20" glass sizes in industrial, commercial, security, and residential configurations. In addition, many of the modern steel windows have integral weatherstripping, thermal break construction, durable vinyl coatings, insulating glass, and other desirable features.

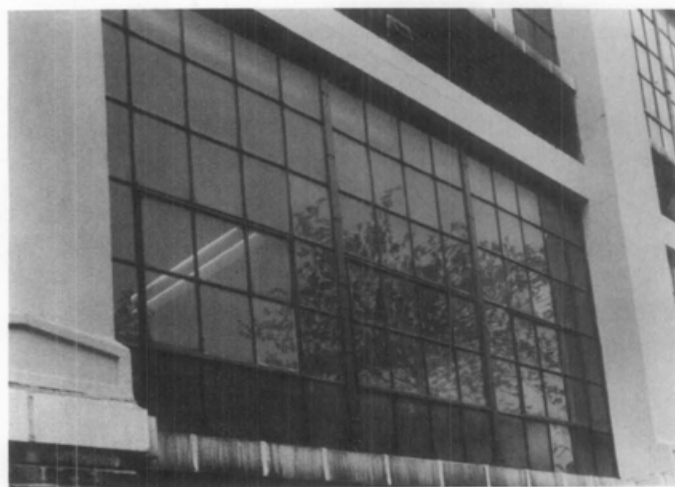
Fig. 10 b. Close-up view of the new replacement steel windows which matched the multi-lighted originals exactly. Photo: Charles Parrott.

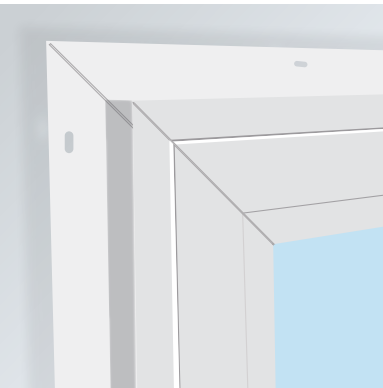
Nail Fin

The nail fin is attached directly to the house's frame in new construction and replacement projects where studs are exposed.

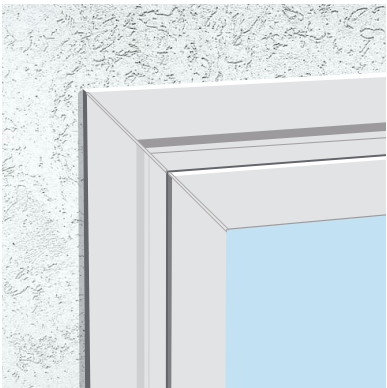
Z-Bar

This configuration comes with a flange on the exterior of the window to cover and seal the frame on homes with stucco.

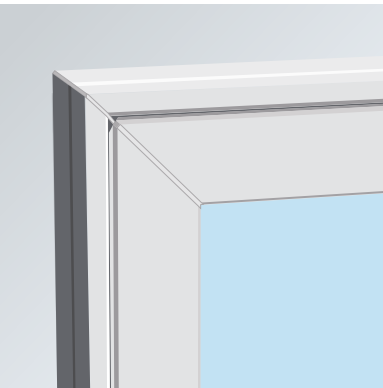
Block

Commonly used for replacement projects, this window inserts into your existing frame, leaving interior and exterior trim undisturbed.
